Aquatic Plant Management in Crooked Lake

Aquatic Ecologist & Certified Lake Manager
Freshwater Scientific Services, LLC

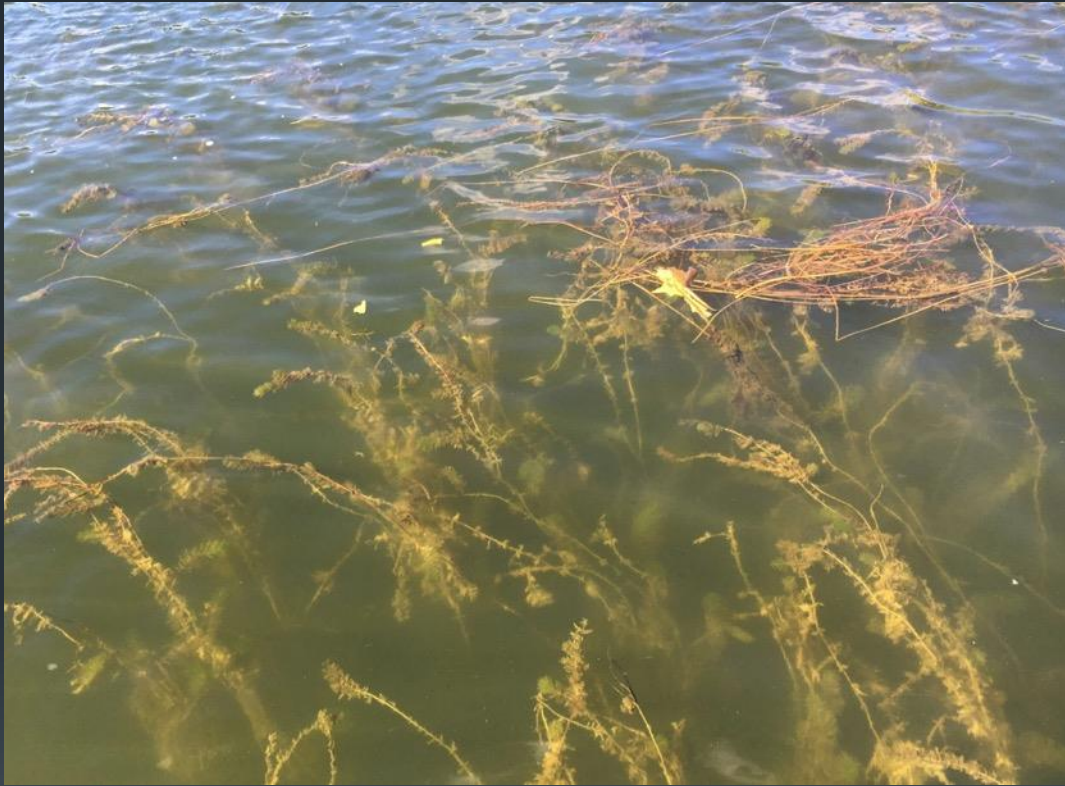
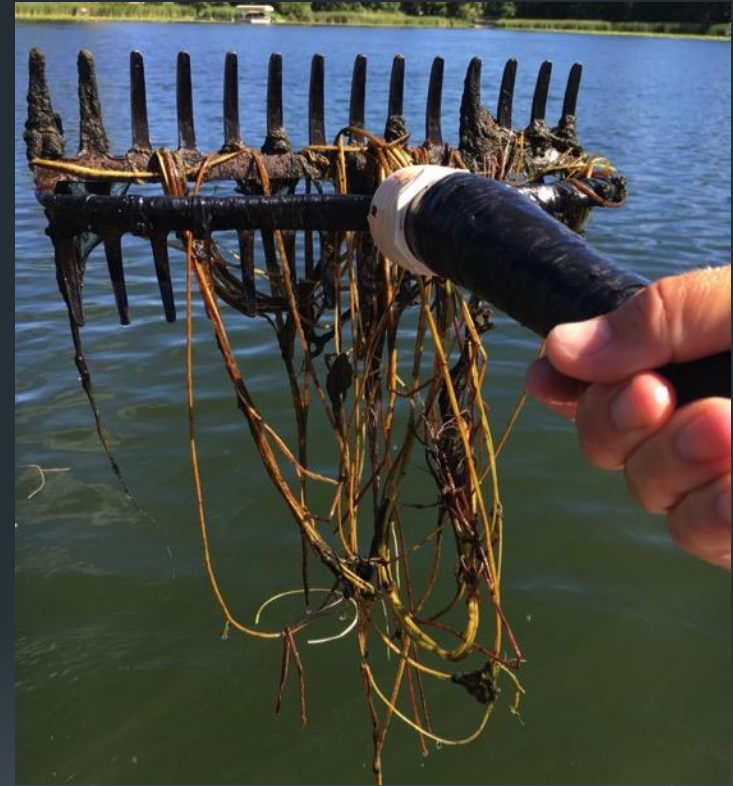
Milfoil Heavily Damaged

**Very Promising Results in 2016:
Milfoil plants lost leaves and collapsed by late summer**

- Granular fluridone herbicide (Sonar™)
- Dosing calculated for lake-wide concentration
- Granules only applied to areas of milfoil

This strategy exposes the milfoil beds to lethal doses of herbicide, while protecting the native plants throughout the rest of the lake
