Potential for Native Aquatic Plant Growth after Control of Eurasian Watermilfoil in Crooked Lake, MN (# 02-0084-00)

2011 – 2012

Native Aquatic Plant Growth after Control of EWM (2011-2012); Crooked Lake, MN

James A. Johnson – Aquatic Ecologist, Freshwater Scientific Services, LLC

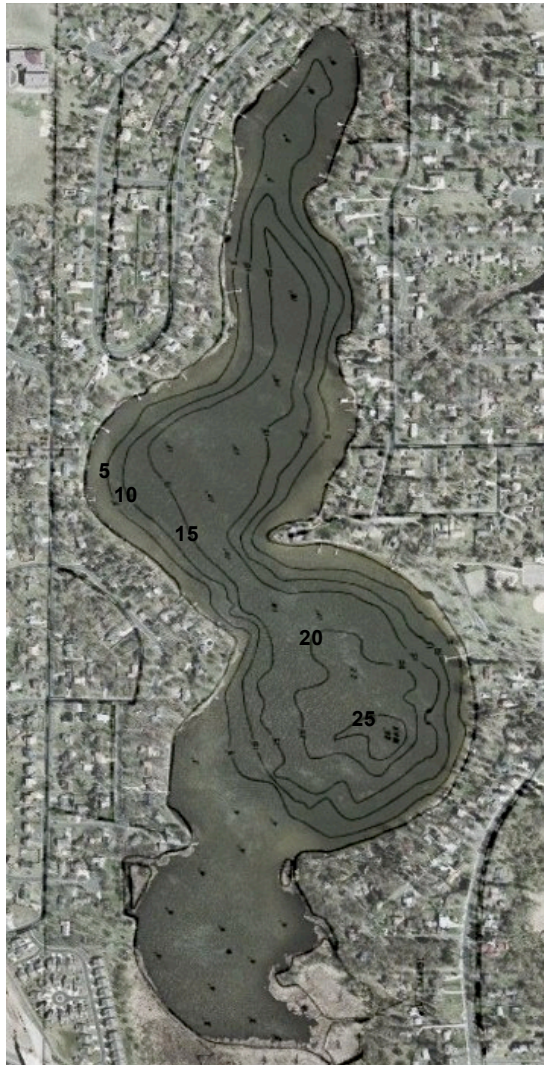
Figure 2. Map of Crooked Lake showing depth contours (MDNR bathymetric map superimposed on aerial image)

Crooked Lake (#02-0084-00) is a small and relatively shallow lake (Table 1) that straddles the border between Coon Rapids, MN and Andover, MN (Figs. 1 and 2). The lake has a public boat access at the far northern end of the lake, and is predominantly used for fishing, waterskiing, and swimming.

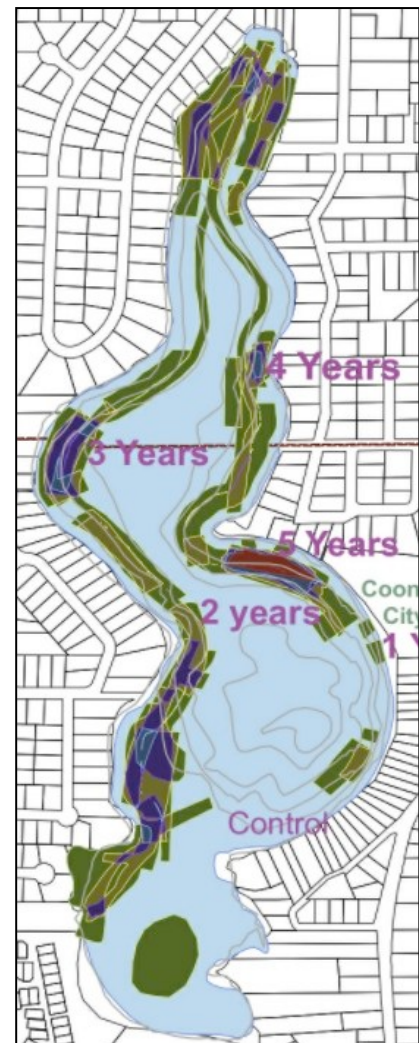
Figure 3. Map of Crooked Lake showing areas that received herbicide spot treatments between 2005 and 2010 (provided by CCWD).

Since 2002, milfoil in Crooked Lake has been managed using localized "spot" herbicide treatments that limited herbicide applications (2,4-D or tricopyr) to areas that supported milfoil growth (Fig. 3). In most years, this approach provided short-term control of milfoil growth in the treated areas, and did not appear to dramatically reduce native plants. However, these treatments did not appear to provide long-term control of the milfoil, as it generally reestablished in many of the treated areas in the subsequent years if left untreated. Consequently, many areas have received treatments in multiple years over the past decade.

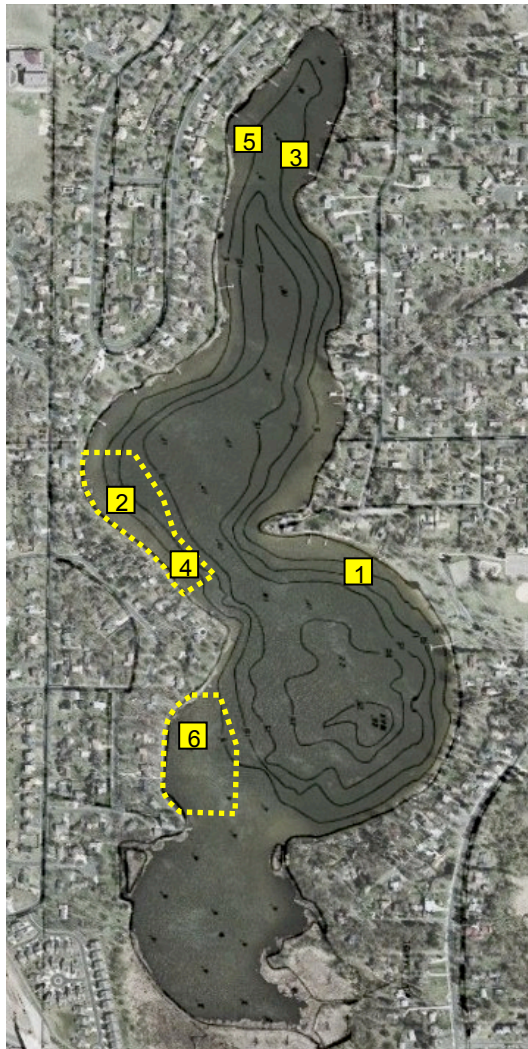
Figure 4. Map showing location and identification of the 6 study plots used in the 2011-2012 study, and the areas treated with triclopyr (dashed lines). Plots are numbered according to water depth from deepest (plot 1) to shallowest (plot 6). Plot symbols on the map do not reflect the actual size of the plots.

We selected 6 nearshore locations for our study plots. All of these selected locations were in areas that had been infested with milfoil in recent years, and that had received some herbicide treatment in the past 5 years. Three of the study plots were located in areas that were treated with triclopyr in 2011 and 2012, with the remaining 3 plots located in areas that were not treated (Fig. 4). These plot locations covered a range of water depths from 2.5 to 6.0 feet and were generally distributed throughout the lake (Figs. 4 and 5). The lake sediment in all six plots was soft, marl, muck, with the southwestern plots appearing to have more marl than the northern and eastern plots.

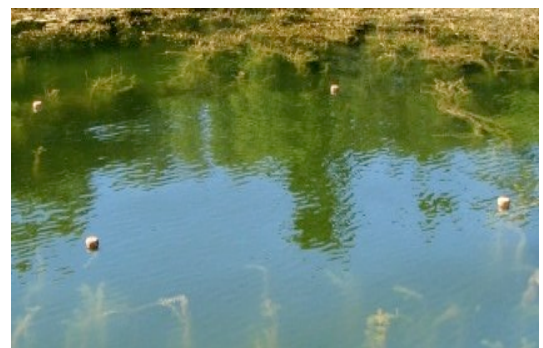
Figure 6. Study plot (plot 2) showing delineated area (12 x 12 ft) and installed plot markers.

In the spring of 2011 and 2012 (early June), we installed plot markers to delineate all 6 study plots (same locations were used in both years). These plot markers were constructed of PVC pipe with a small fish-net float tethered by 2 ft of nylon rope (Fig. 6). For each plot, we placed these markers to delineate the corners of a 12 x 12-ft square area. These low-profile markers were selected to (1) minimize damage to boats that accidentally ran over them, (2) maintain views of the lake from shore, and (3) reduce the likelihood of vandalism. In 2011, two plot markers were removed by lake users (one at plot 1 and one at plot 4), but on both occasions we were easily able to replace these markers; in 2012, no plot markers were removed.

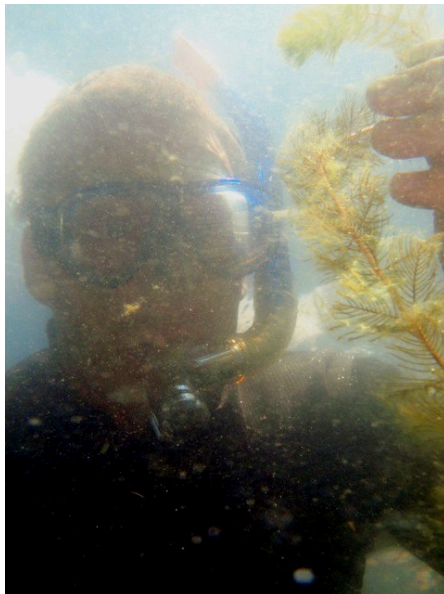
Figure 7. James Johnson (Freshwater Scientific Services, LLC) removing Eurasian watermilfoil from study plot in 2011.

After marking the study plots, we inspected each plot while snorkeling and manually removed all of the milfoil we found growing within each plot (June 14-15; Figs. 7 and 8). When removing milfoil, we were very careful to avoid disturbing native plants (no flippers; maneuvered with hands only), and removed entire milfoil plants (shoots and roots) to minimize regrowth. All of the collected milfoil plants were placed into a plastic garbage bag, removed from the lake, and disposed of according to MDNR rules. We conducted several additional snorkel inspections of the plots in June, July, and August of each year. All milfoil plants found growing in the plots during these subsequent inspections were removed using the same procedure as described above. The repeated removal of milfoil dramatically reduced its the abundance in the study plots relative to the areas immediately outside of the plots (Figs. 6 and 8), and successfully prevented formation of dense milfoil canopy growth within the plot areas.

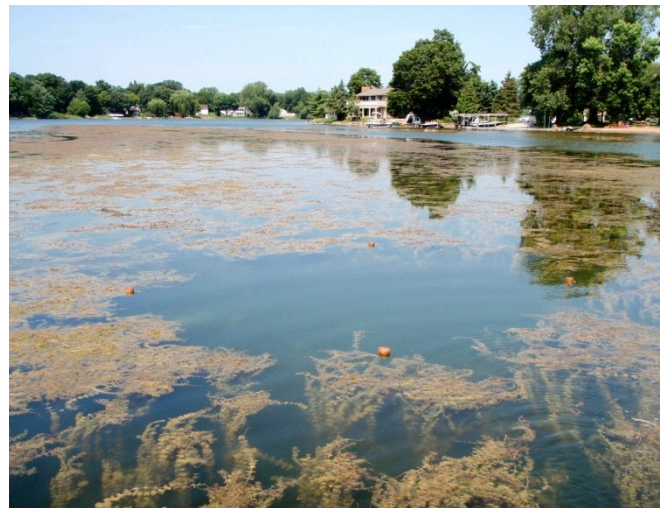
Figure 8. Study plot 1 (August 2012) showing dramatically reduced Eurasian watermilfoil inside the plot relative to the area immediately outside the plot after periodic removal of milfoil. (Also evident in Fig. 6)

Percent cover indicates how much of the sediment in each plot was covered by plants. Comparison of the % cover for each plant taxon across our study plots clearly shows that % cover differed both between plant taxa (Fig. 12) and between plots (Fig. 13). Although we found milfoil growing in all but one of the plots in 2011 and in all plots in 2012, it covered less than 5% of the area surveyed in plots 2, 3, 4, and 6, and less than 10% in plot 5. However, in plot 1 (deep and not treated) milfoil covered 26% of the surveyed area in 2011 and 14% in 2012. Most of the milfoil plants found in plot 1 appeared to be rooted fragments (most plants were rooted from horizontal stem section) rather than new growth from seeds or roots, suggesting that this area may have experienced frequent motorboat traffic and settling of milfoil fragments. The very low % cover of milfoil in most of the plots indicated that the manual removal effectively minimized its competition with native plants. Furthermore, we did not see dense canopy formation in plot 1, despite the higher frequency of milfoil in that plot (Fig. 8).

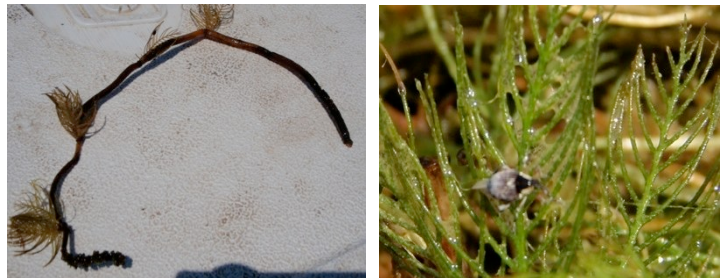
Figure 18. Blackened milfoil stem collected near plot 5 in 2012– likely damage from milfoil weevil larvae (left); adult milfoil weevil found on milfoil removed from plot 5 in 2012.

Milfoil currently dominates much of the littoral area of Crooked Lake. This dense milfoil clearly interferes with the dominant recreational uses of the lake (waterskiing, fishing, swimming). Future management should strive to minimize the level of impairment from milfoil while protecting native aquatic plants in the lake. Although I did see evidence of milfoil weevil damage and one adult weevil in 2012 (Fig. 18; formal weevil survey not conducted), these “biocontrol agents” did not effectively control milfoil in the lake. Recent herbicide treatments appear to provide good seasonal control of milfoil in the treated areas. However, given the MDNR 15% littoral limit for maximum treatment area, the CLAA will likely find it difficult to maintain low milfoil abundance unless it seeks a variance to treat more of the littoral area. I recommend that the CLAA submit a short-form lake vegetation management plan (LVMP) and apply for a variance permit in early in 2013. The variance request should propose a maximum treatment area equal to the area that has supported dense milfoil growth in recent years (~30 to 40% of the littoral area). The CLAA should also commit to annual monitoring of milfoil and native plants in the lake. Based upon the findings from this monitoring, the treatment areas should be adjusted accordingly each year to minimize treatment costs and reduce impacts to non-target plant species.
