Eurasian Watermilfoil in Crooked Lake (WBIC# 02-0084)

Anoka County, MN

Spring Delineation Survey – May 30, 2013

Prepared for the Crooked Lake Area Association – June 2013

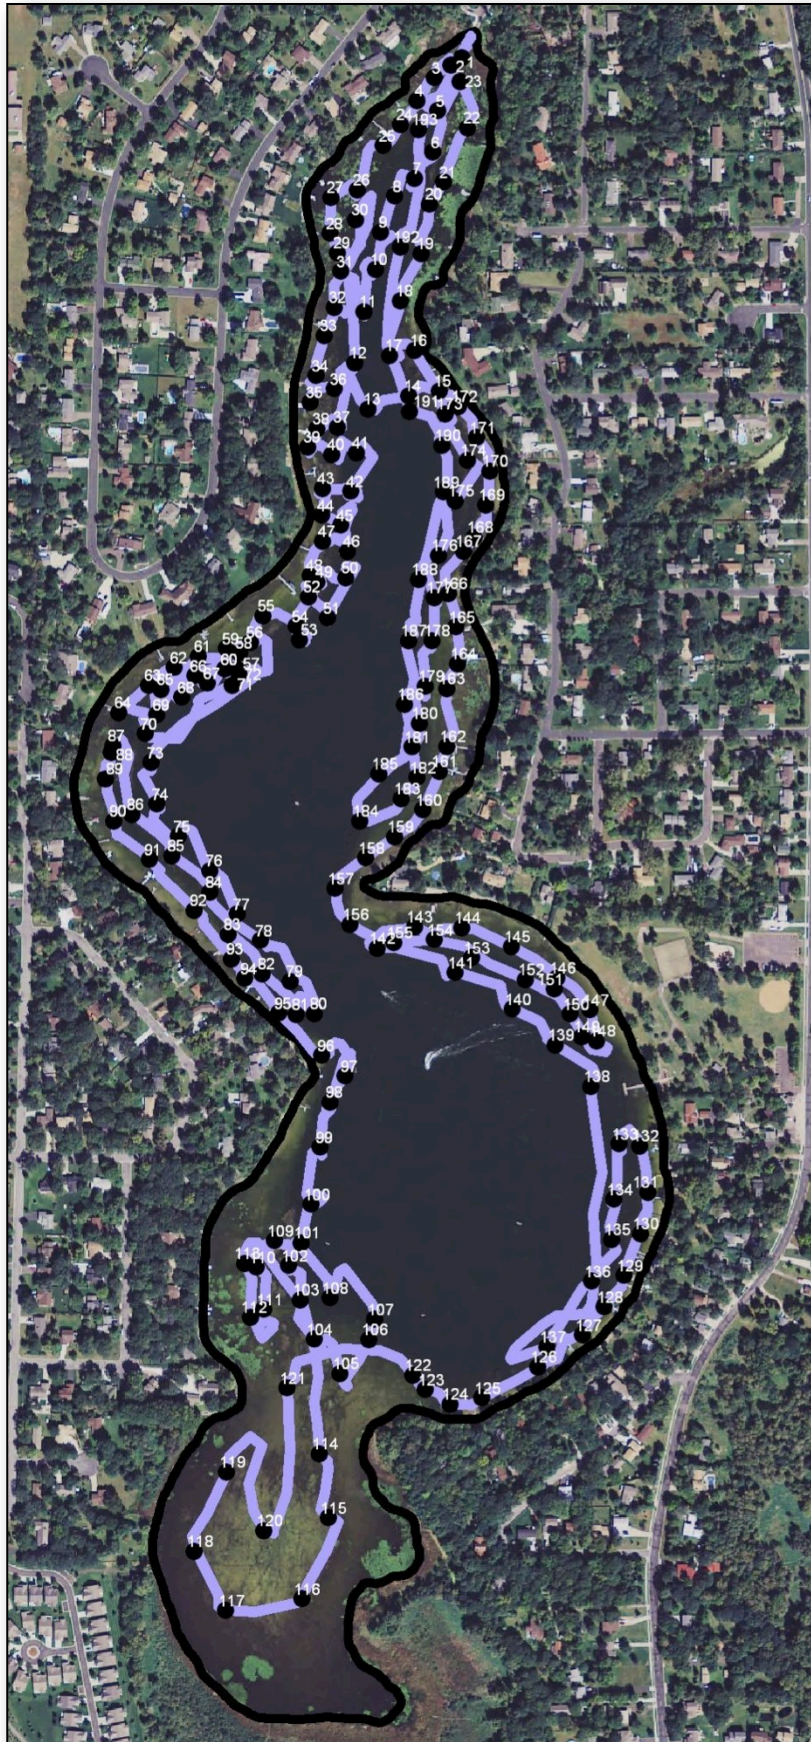
EWM Spring Delineation Survey May 30, 2013

Surveyed Locations

Surveyed Path
-

Surveyed Points (rake tosses)

See Table 1 for detailed point descriptions (by number)

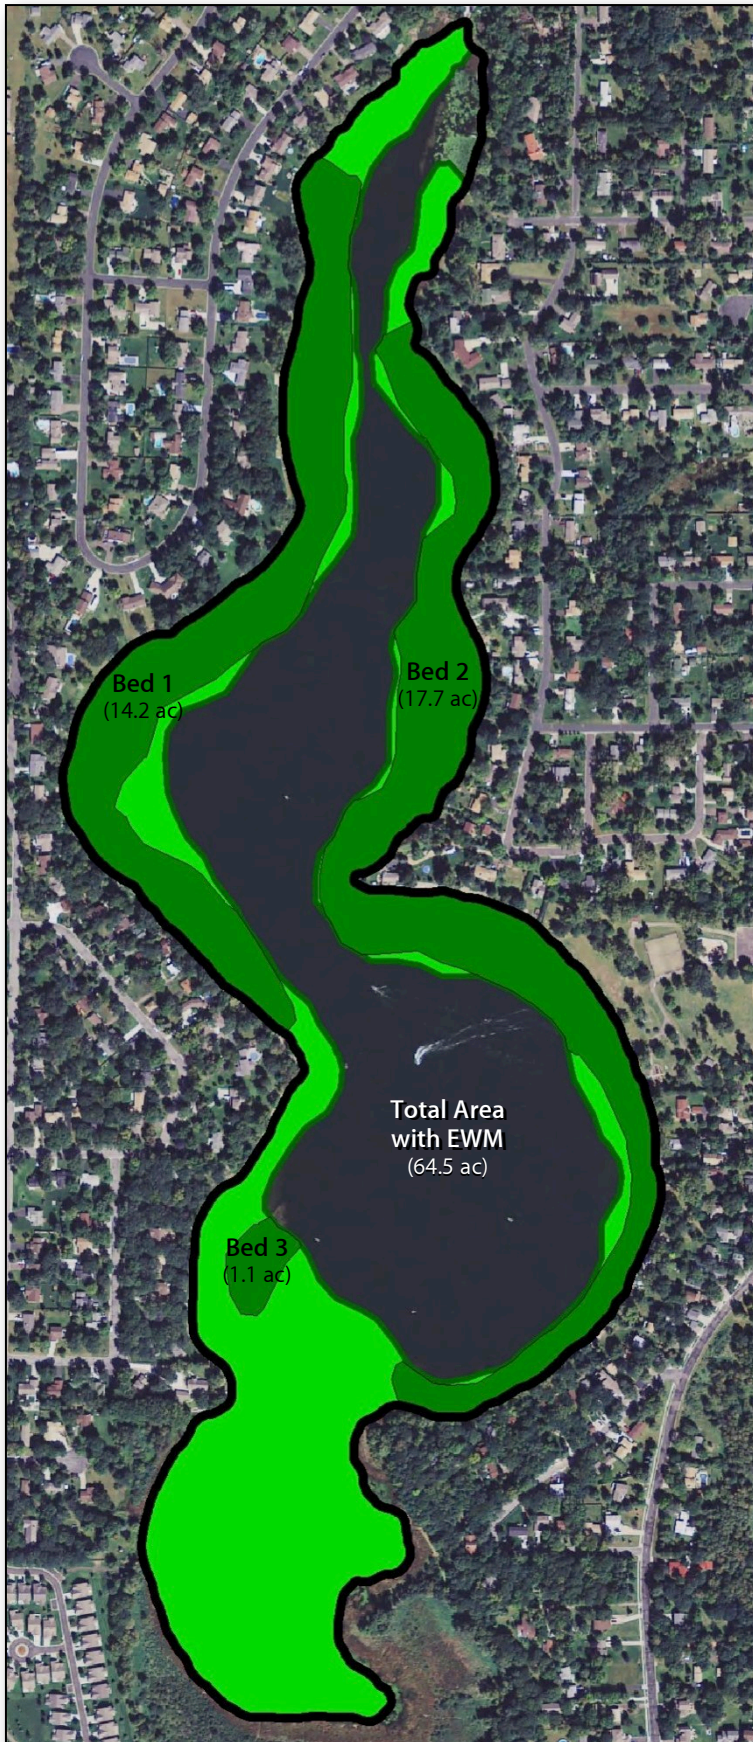
EWM Spring Delineation Survey May 30, 2013

EWM Bed Delineation

Low Density EWM
(rake density = 1)
-

Moderate to Dense EWM
(density rating ≥ 2)

See Table 2 for detailed descriptions of each designated bed

Table 2. Details for delineated beds of moderate to dense Eurasian watermilfoil (EWM) and lakewide EWM growth in Crooked Lake (May 30, 2013). See page 7 for map of delineated beds.

Bed ID	Area (acres)	Mean Water Depth (ft)	Mean EWM Height (ft)	Mean EWM Density (rake, 0-4)
1	14.2	5.2	3.3	2.0
2	17.7	4.8	3.3	2.0
3	1.1	3.7	2.5	1.7
All 3 Beds	33.0	4.9	3.3	2.0
Lakewide	64.5	5.7	2.6	1.5
