Crooked Lake

Comprehensive Lake Management Plan 2014-2018

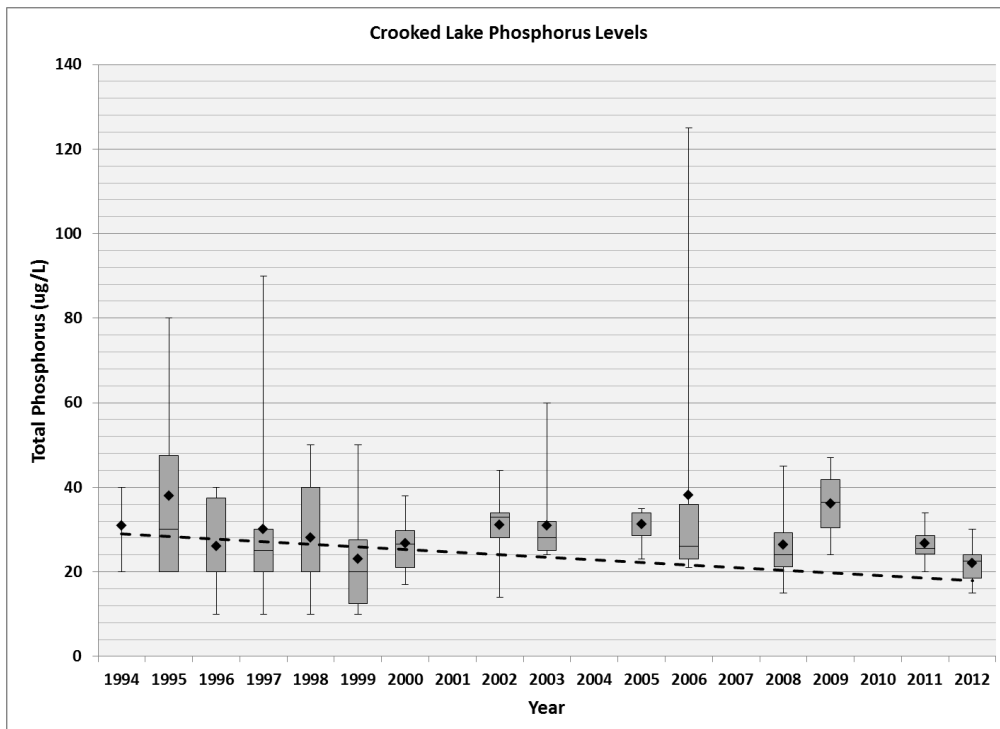
Total phosphorus measures both the dissolved and particulate forms of phosphorus to determine the availability of nutrients for uptake by plant and algal growth. Over the past 5 years, annual average TP concentrations dropped to 27.85 $\mu\text{g/L}$. This is roughly half the annual concentration observed during the 1980's (50 $\mu\text{g/L}$). Phosphorus concentrations have decreased from the beginning of Crooked Lake water quality monitoring in 1983 (Figure 8). During the 1980s the annual average phosphorus concentration was 50 $\mu\text{g/L}$. From 2004 to 2008 the annual average phosphorus concentration was 32.0 $\mu\text{g/L}$, a 18 $\mu\text{g/L}$ reduction since the 1980's. In 2012, average annual TP concentrations dropped to 22 $\mu\text{g/L}$; the lowest recorded observation in Crooked Lake.

Figure 8. Crooked Lake Phosphorus Concentrations. Box plots show median (middle line), 25th and 75th percentile (boxes) and min/max observations (vertical lines).

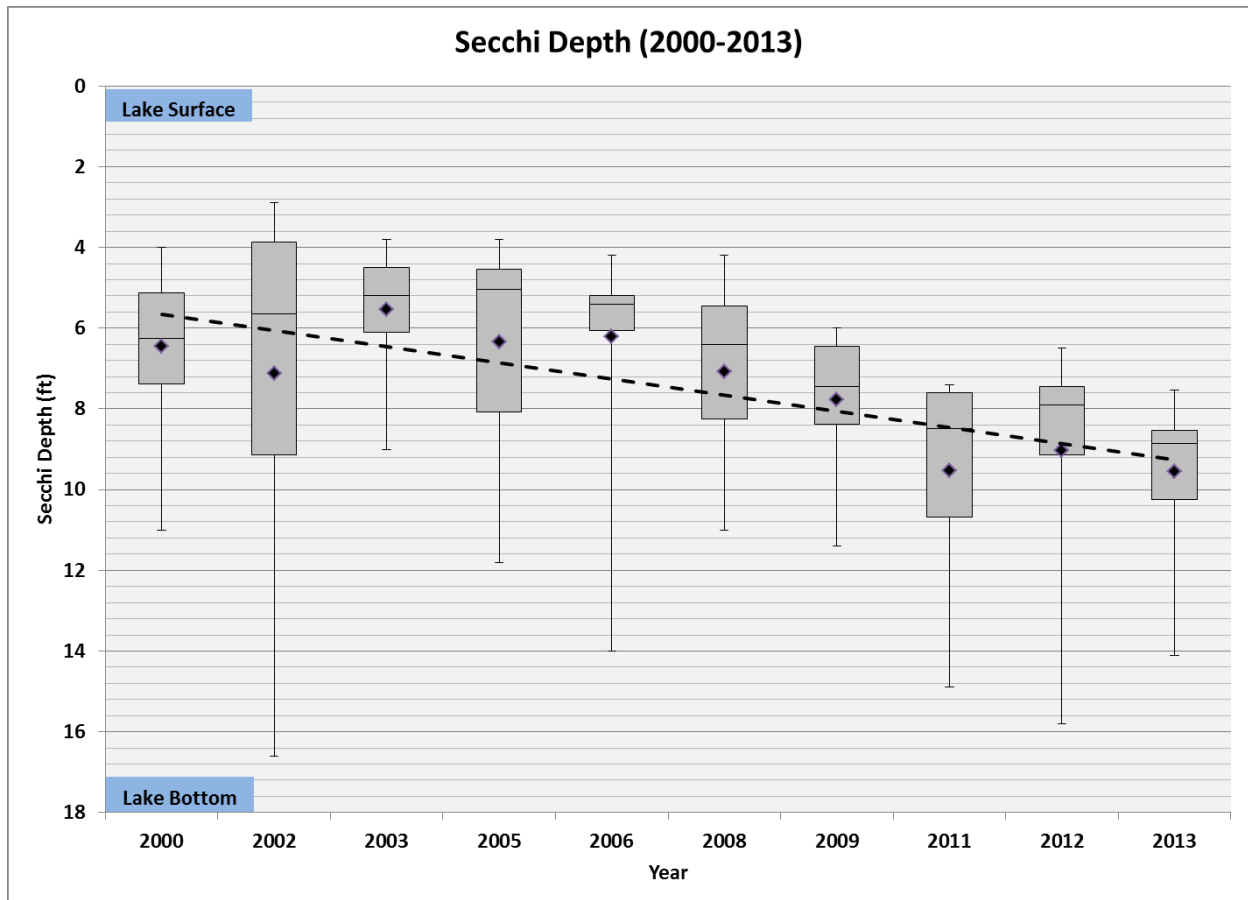
Figure 10. Secchi depth readings for Crooked Lake.

The annual average secchi depth for the 1980s was 3.78 feet. The annual average from 2000-2008 is 6.45 feet, a 2.67 foot increase compared to the 1980's. Since 2008, annual average transparency has reached 8.97 feet equating to a 2.52 foot increase from the previous five years (Figure 10).

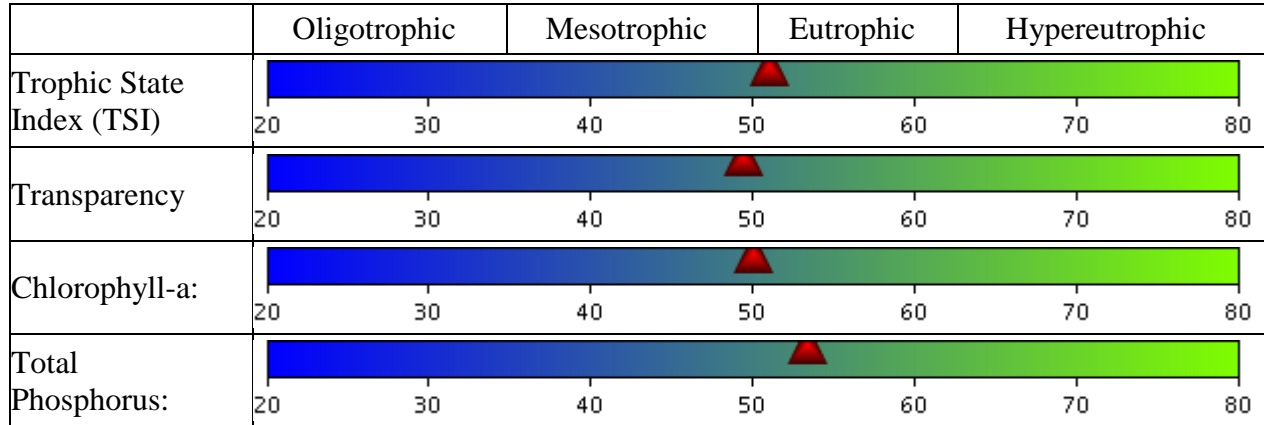
Figure 11. Trophic State Index for Crooked Lake

The Trophic State Index (TSI) is a number summarizing overall nutrient richness of a given waterbody. Nutrient richness ranges from clear lakes, low in nutrients (oligotrophic), to green lakes, with very high nutrient levels (hypereutrophic). Figure 11 below shows the overall TSI rating for Crooked Lake (top bar), followed by TSI ratings for the individual parameters that contribute to nutrient richness. These TSI calculations are based on data collected between June and September 2003 to 2012. Figure 12 gives a general portrayal of expected water clarity for each trophic state.

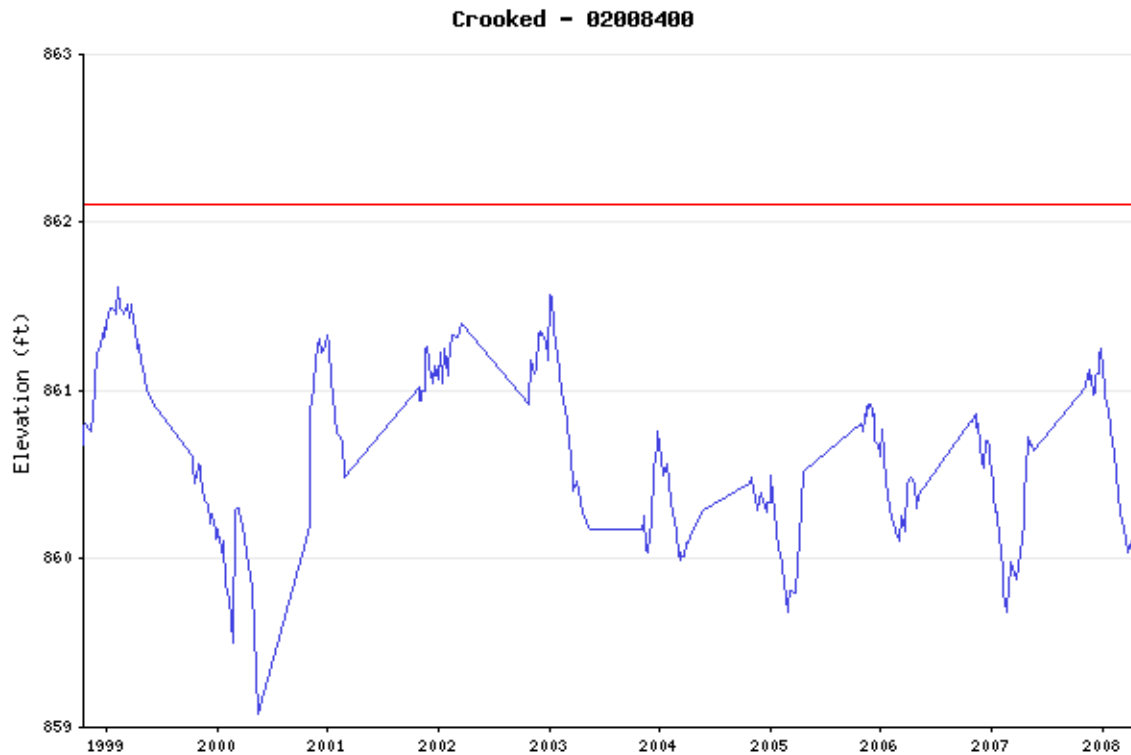
Figure 3.8 Crooked Lake Levels

Highest recorded: 861.94 ft (05/16/1986)
 Lowest recorded: 858.54 ft (08/29/1988)
 Recorded range: 3.4 ft
 Average water level: 860.76 ft
 Last reading: 861.02 ft (4/29/2008)
 Ordinary High Water (OHW) elevation: 862.1 ft

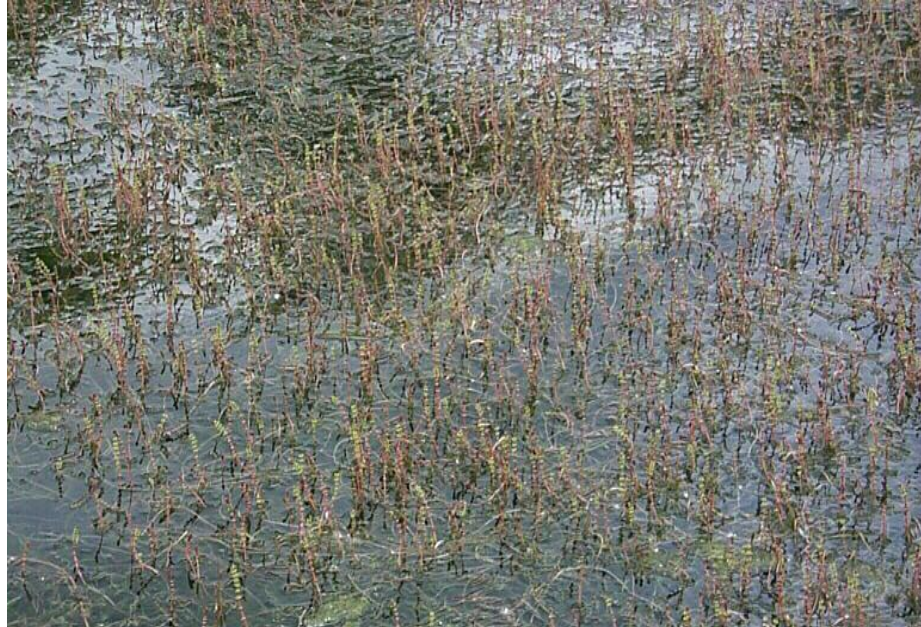
Eurasian water milfoil & curly leaf pondweed

In the eyes of the public, the presence of Eurasian watermilfoil and curly leaf pondweed was the most-often cited problem needing to be addressed. Both species interfere with recreational and aesthetic use of the lake.

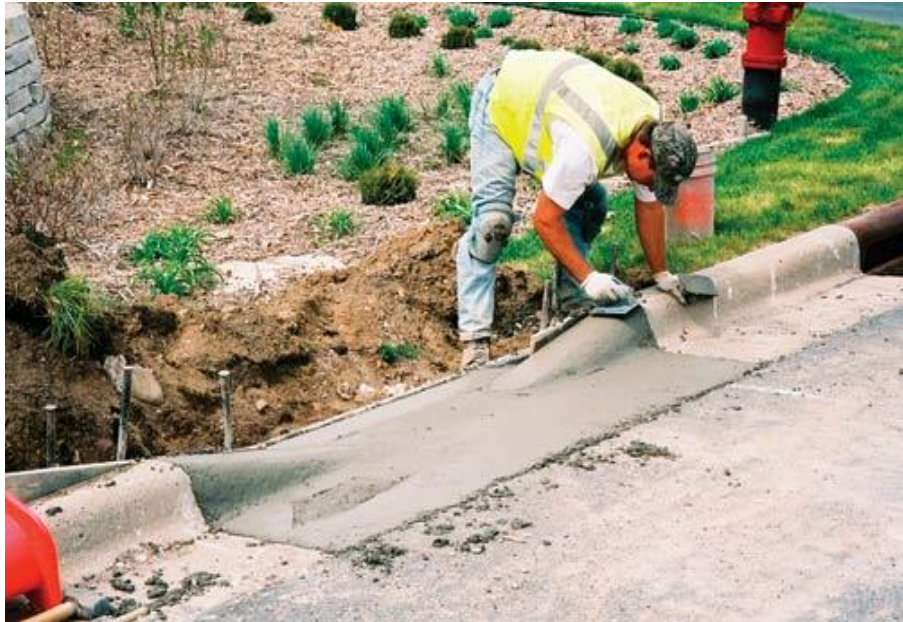
- Rain gardens for individual houses or buildings are generally between 100 to 400 square feet in size, although they can be much larger if you have a very large impervious area to treat.
- The exact size of the garden should be determined by calculating the square footage of roof or pavement which will drain to the garden, and making the garden about 30% of this area.
- Rain gardens should be sited in a level to gently sloping area and at least 10 feet from building foundations.
- If a building has rain gutters, it is usually simplest to site the garden where rainwater from one of the gutter downspouts can easily be directed into the garden.
- Edging (rocks, cobbles, plastic, etc.) can be used to create a defined look and help keep out weeds & grass.
- Be aware of underground service lines or utilities! Call the local utility company or Gopher State One Call before digging!

Cuts in the curb allow stormwater to enter the gardens from the street.
