## Early-Spring Curlyleaf Pondweed Delineation

**Crooked Lake (# 02-0084)**  
Anoka County, MN

Surveyed May 10, 2018

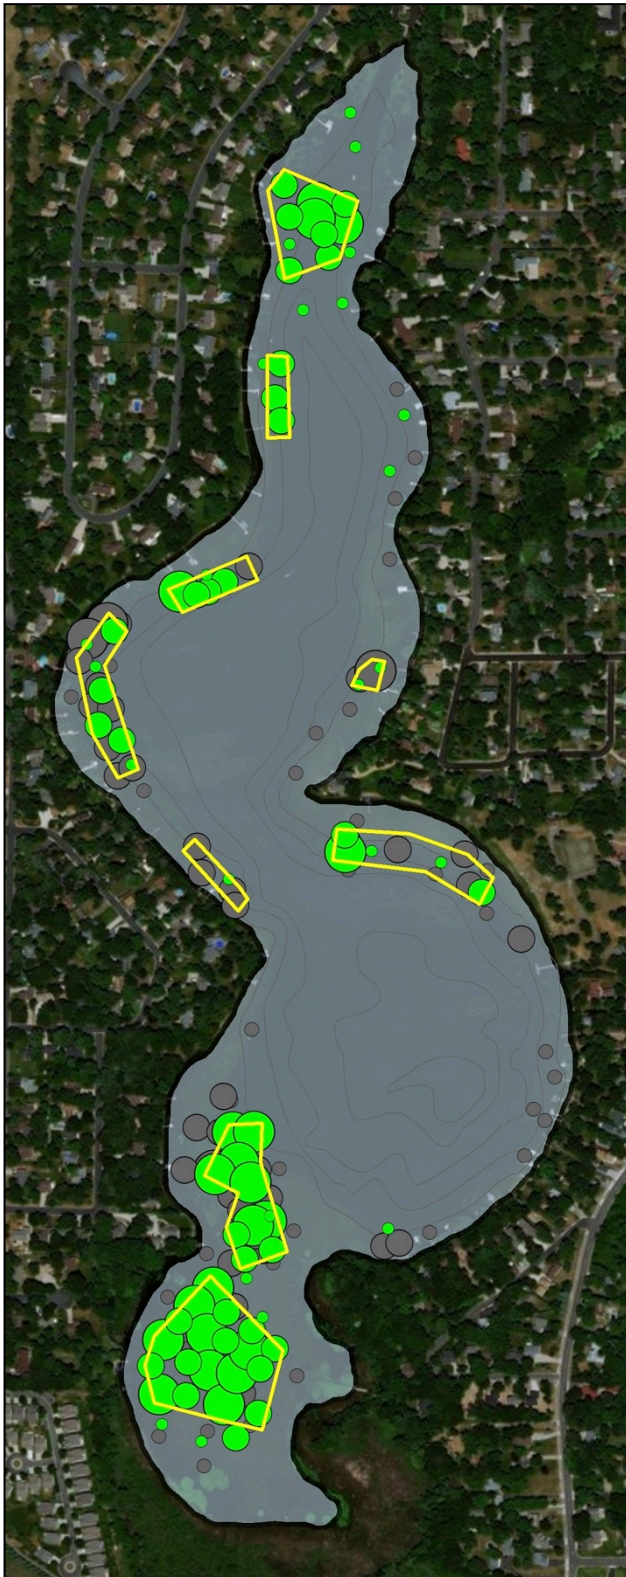
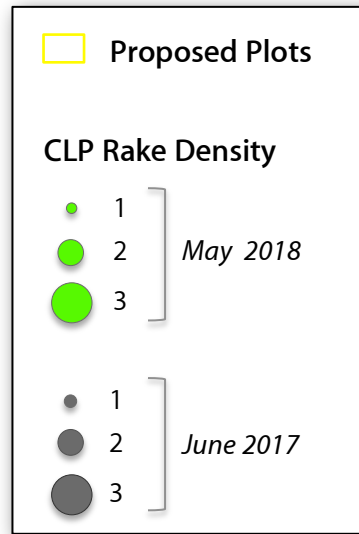
## 2018 Early-Spring Delineation of Curlyleaf Pondweed Crooked Lake (# 02-0084)

Surveyed: May 10, 2018 / Jun 14, 2017  
Methods: Visual, Sonar, Rake  
Surveyor: JA Johnson

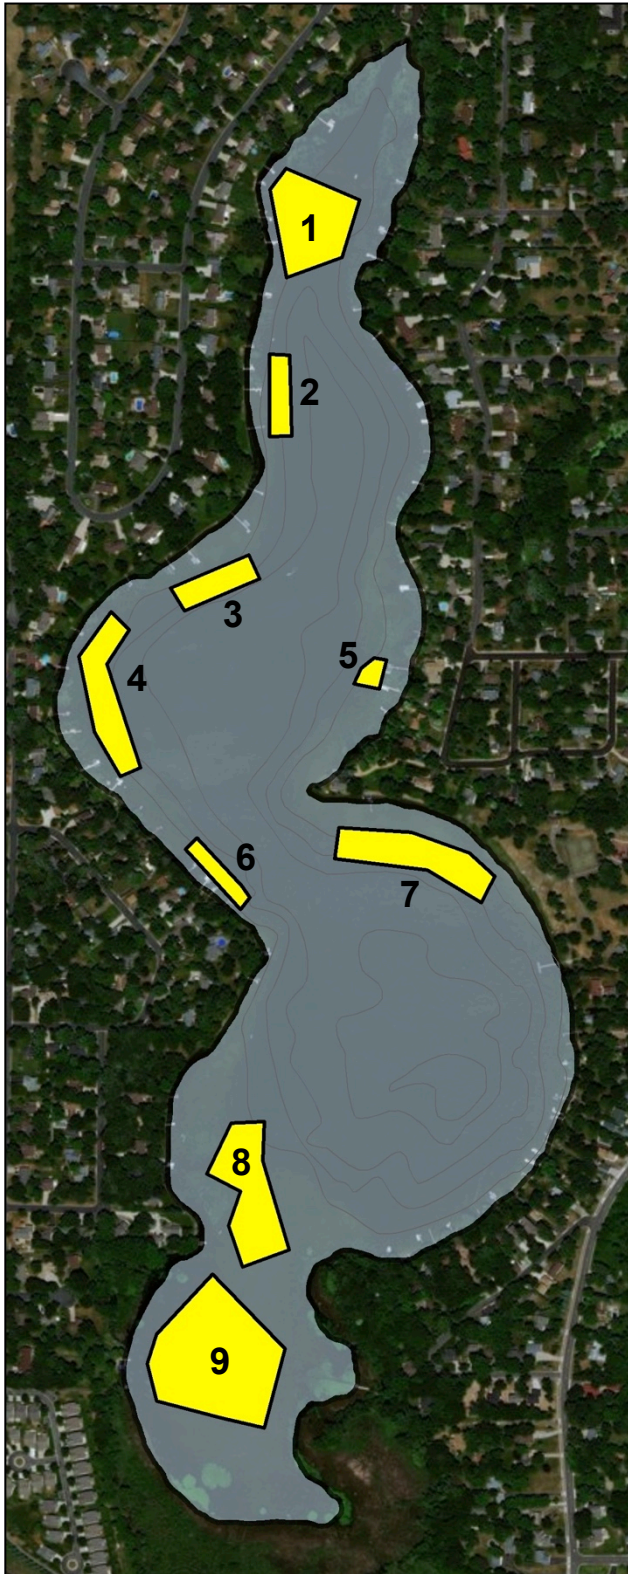
## 2018 Early-Spring Delineation of Curlyleaf Pondweed Crooked Lake (# 02-0084)

Potential Management Plots

Plot	Area (acres)	Mean Depth (ft)	Mean EWM Density (1-3)
1	2.1	5.4	2.2
2	0.6	7.3	2.0
3	0.7	6.3	2.0
4	1.5	5.5	1.6
5	0.2	3.6	1.0
6	0.4	7.5	1.0
7	1.8	5.1	1.8
8	2.1	3.4	2.5
9	4.4	2.7	2.5

**Total 14.8**

Surveyed: May 10, 2018 / Jun 14, 2017  
 Methods: Visual, Sonar, Rake  
 Surveyor: JA Johnson
