Eurasian Watermilfoil & Curlyleaf Pondweed Delineation

Crooked Lake (# 02-0084)

Anoka County, MN

Surveyed June 14, 2017

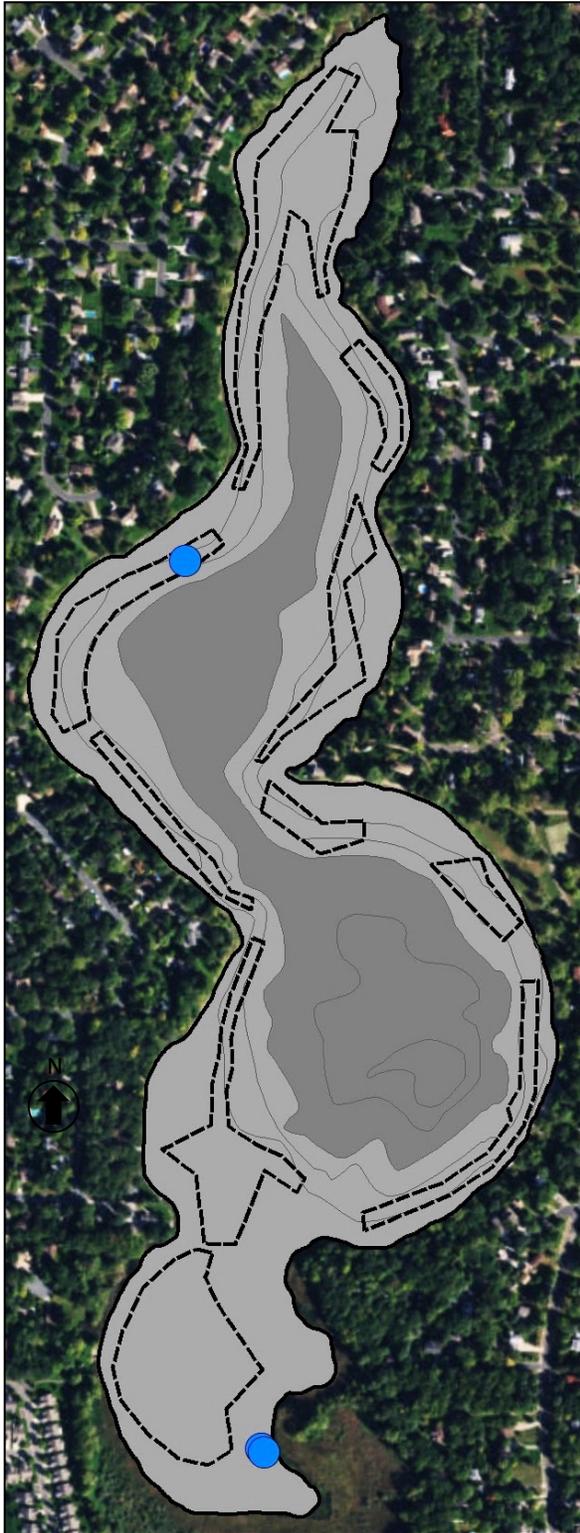
2017 Late-Spring Delineation of Eurasian Watermilfoil Crooked Lake (# 02-0084)

We found no EWM during the survey conducted on June 14, 2017. However, MDNR staff found one small EWM fragment in a rake sample collected along the northwest shore in June, and we discovered 2 additional solitary EWM plants growing at the edge of lilies in the far southern tip of the lake while conducting the native plant transplantings at the end of June. Other than these two locations, we observed no additional EWM plants in Crooked Lake. These results are remarkable and strongly suggests that the experimental granular sonar treatment conducted in 2016 effectively controlled EWM lake-wide.

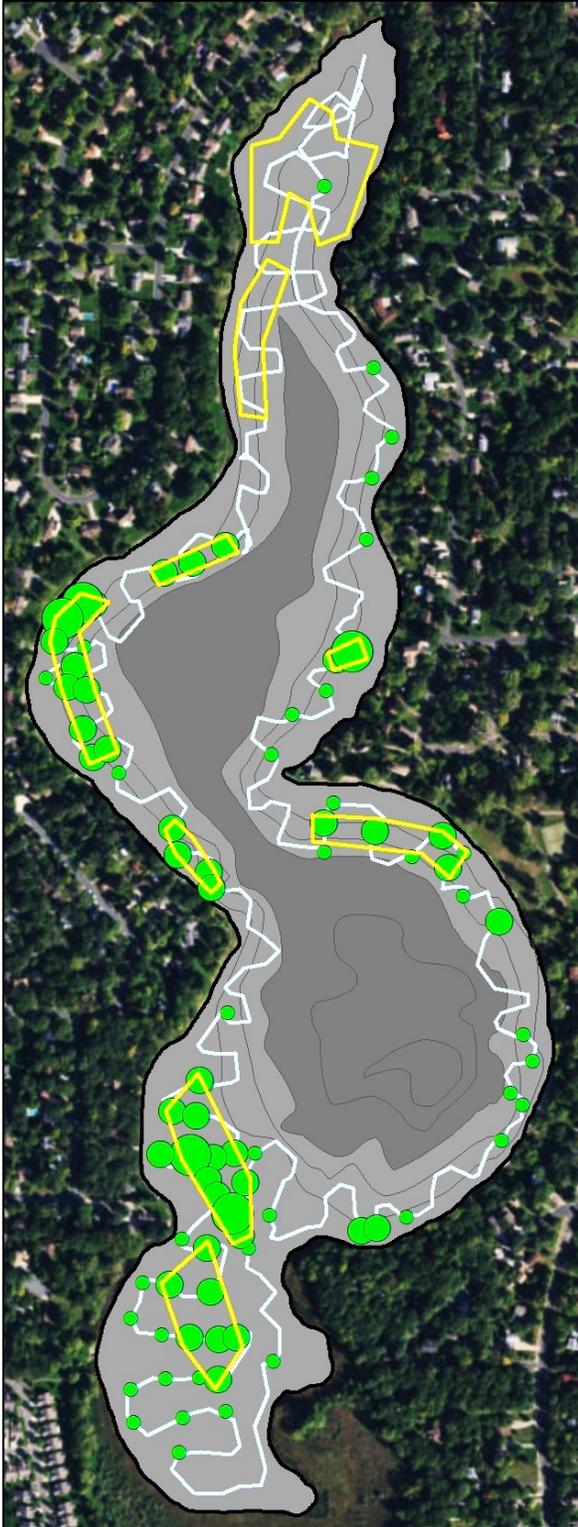
2017 Late-Spring Delineation of Curlyleaf Pondweed Crooked Lake (# 02-0084)

In past years, EWM dominated a substantial portion of the littoral area (≤ 15 ft). The reduction of EWM in the lake likely allowed for more light penetration. Consequently, the amount of CLP that reached the surface of the lake was greater in 2017 than in past years. Although CLP was fairly widespread in 2017, most CLP growth was very sparse and patchy; only a few locations supported stands of nuisance-level growth. Plots 1 and 2 (see page 5) were treated in 2017 prior to conducting this survey, but it is reasonable to expect that these areas will still produce dense CLP in future years. In addition, plots 4, 8, and 9 supported moderate to high-density CLP growth that will likely impair recreation in 2018 if not treated.

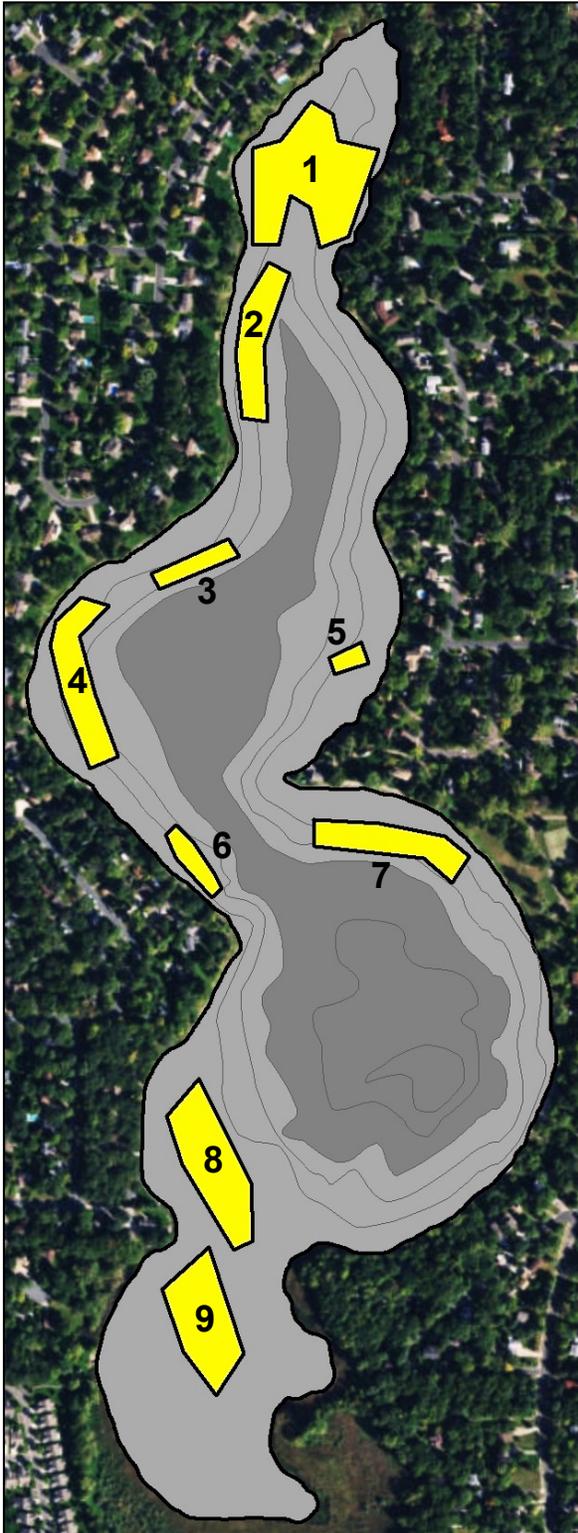
Potential CLP Management Plots

Plot	Area (acres)	Mean Depth (ft)	Mean EWM Density (1-3)
1	3.6	3.9	2.1
2	1.4	5.7	1.6
3	0.5	5.9	2.0
4	1.7	4.5	2.2
5	0.2	4.1	2.5
6	0.5	4.1	2.0
7	1.4	3.9	1.8
8	2.3	3.0	2.2
9	2.0	2.5	2.0
