## Eurasian Watermilfoil in Crooked Lake (WBIC# 02-0084)

Anoka County, MN

Spring Delineation Survey – June 5, 2014

Prepared for the Crooked Lake Area Association – June 2014

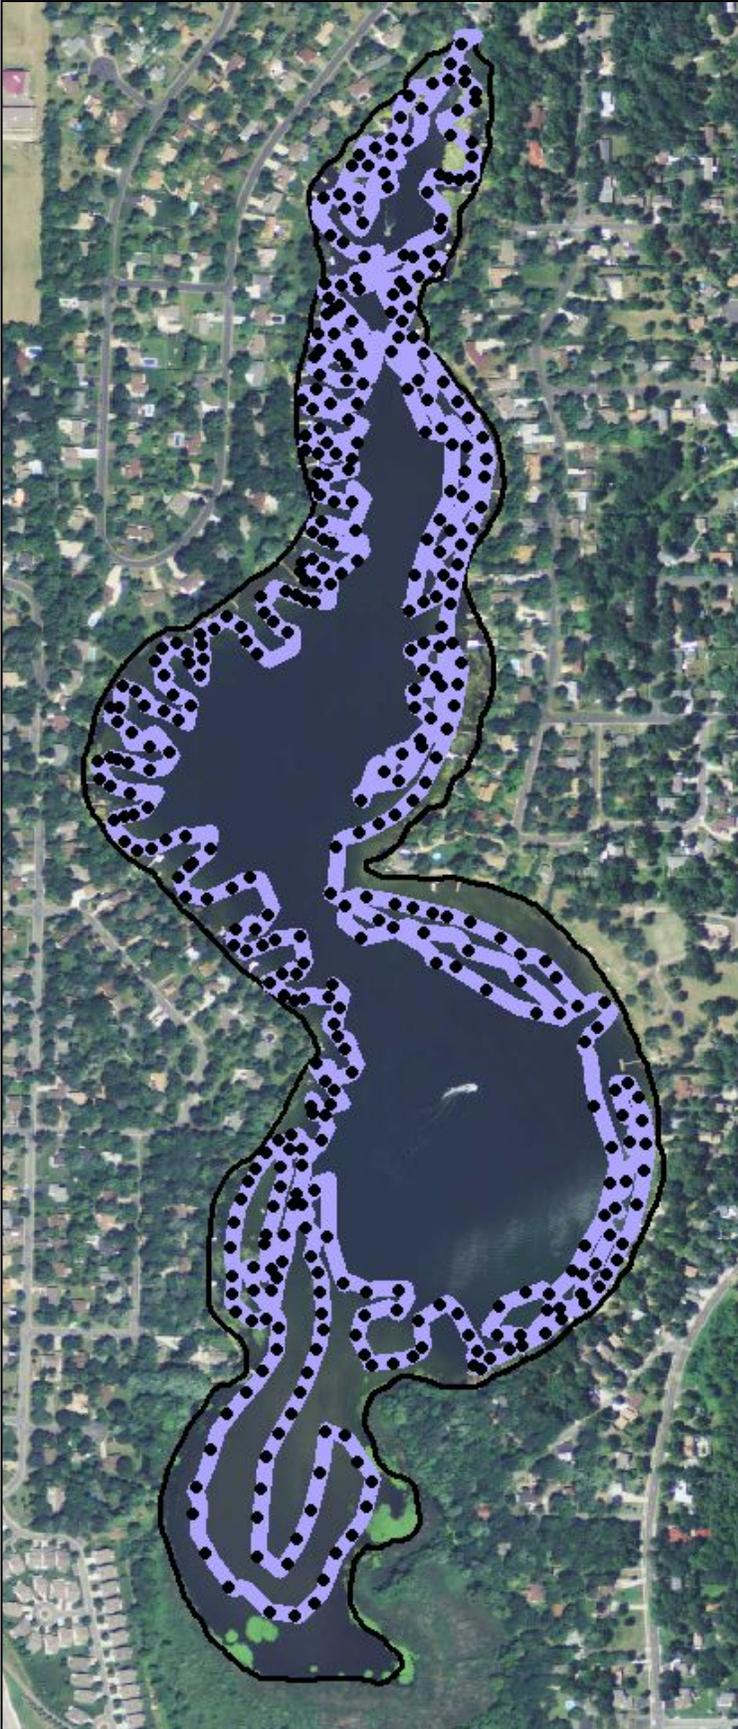
## EWM Spring Delineation Survey June 5, 2014

**Surveyed Locations**

Surveyed Path
-

Surveyed Points

See Table 1 for detailed point locations and descriptions

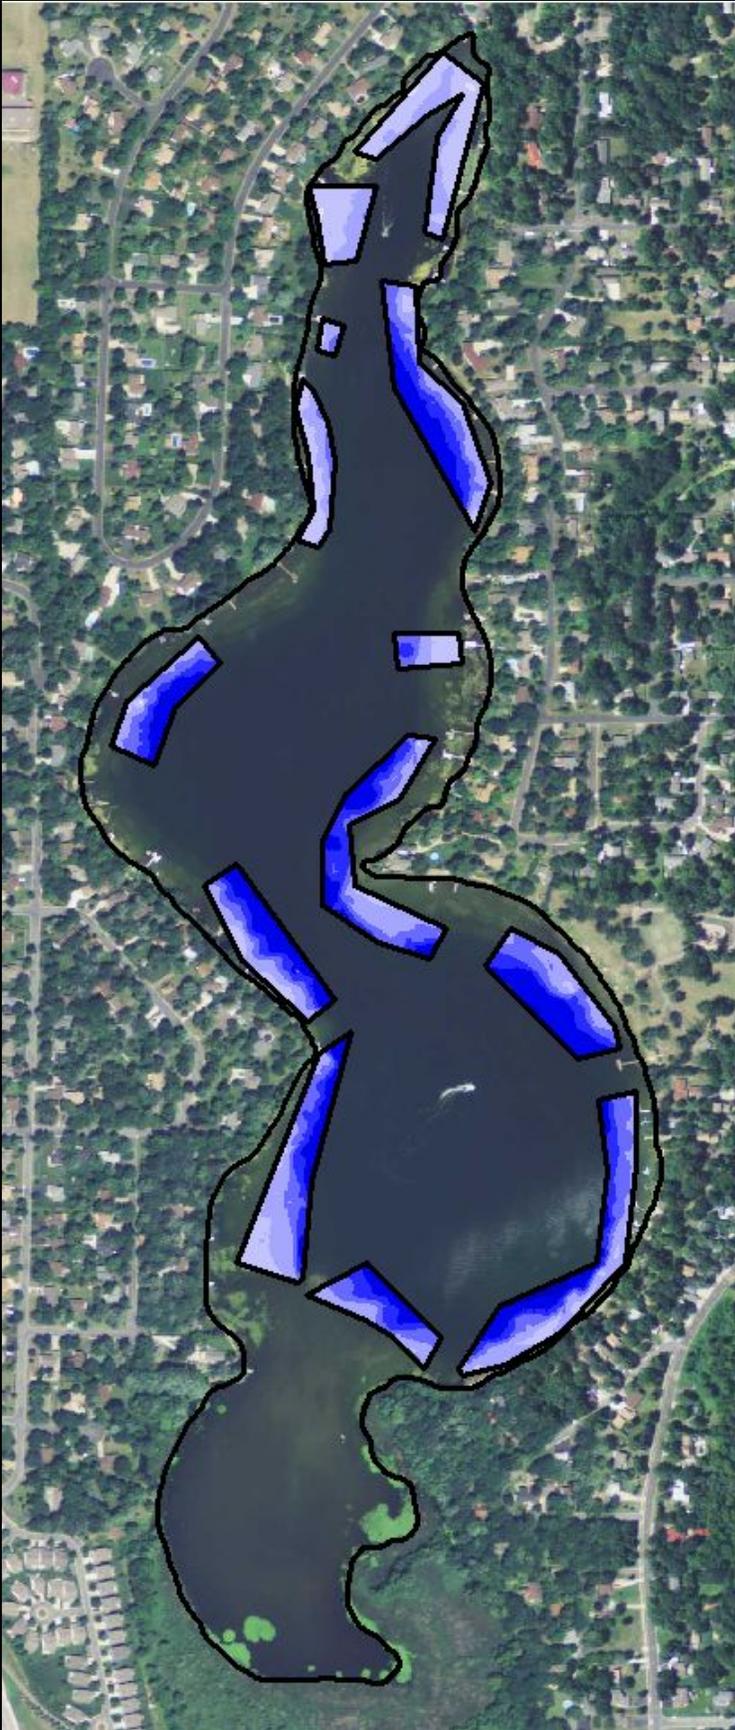
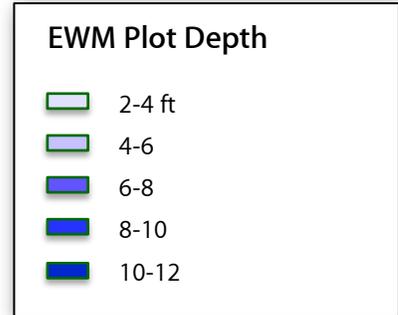
## EWM Spring Delineation Survey June 5, 2014

**Crooked Lake**  
Anoka County, MN  
#02-0084

Surveyed: June 5, 2014  
Surveyor: J.A. Johnson  
Affiliation: Freshwater Sci. Serv.  
Methods: Visual, Rake, Sonar, Camera  
Analyses by: J.A. Johnson
