Early-Spring Curlyleaf Pondweed Delineation

Crooked Lake (# 02-0084)

Surveyed April 6, 2020

2020 Early-Spring Delineation of Curlyleaf Pondweed Crooked Lake (# 02-0084)

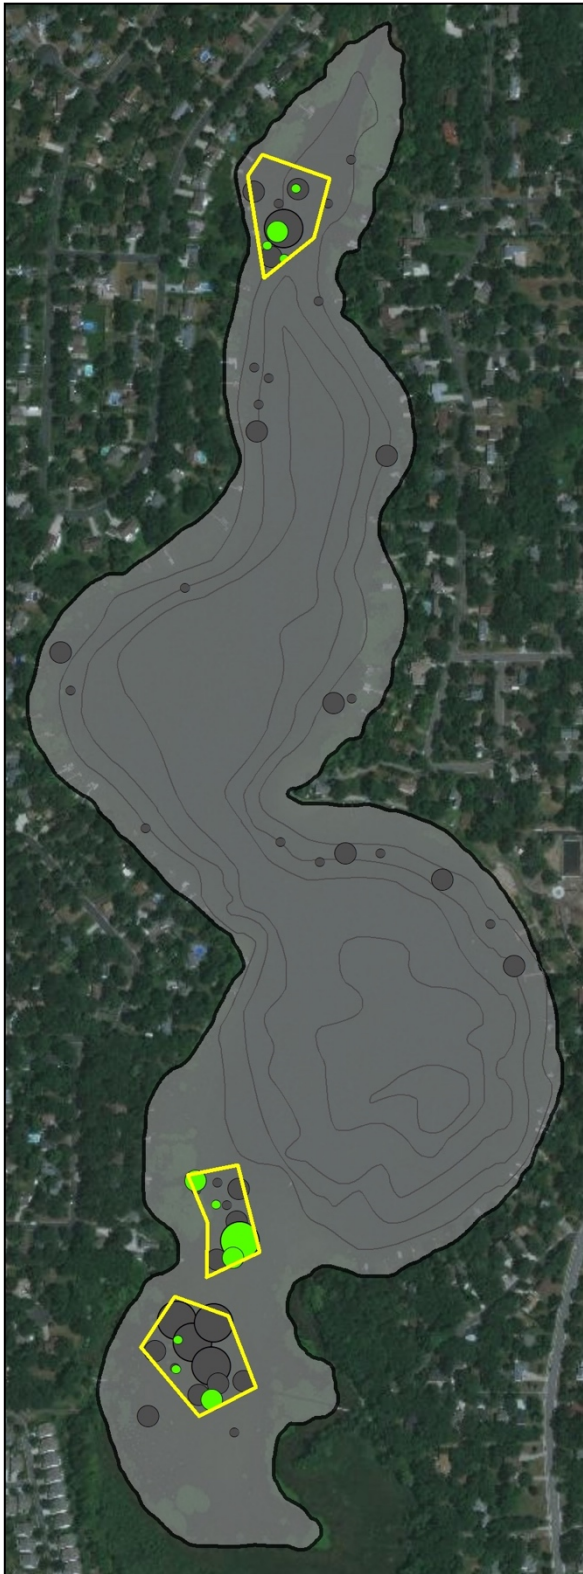
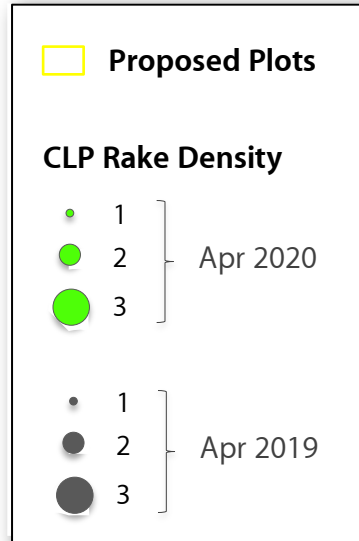
Surveyed: Apr 6, 2020
Methods: Visual, Sonar, Rake
Surveyor: JA Johnson

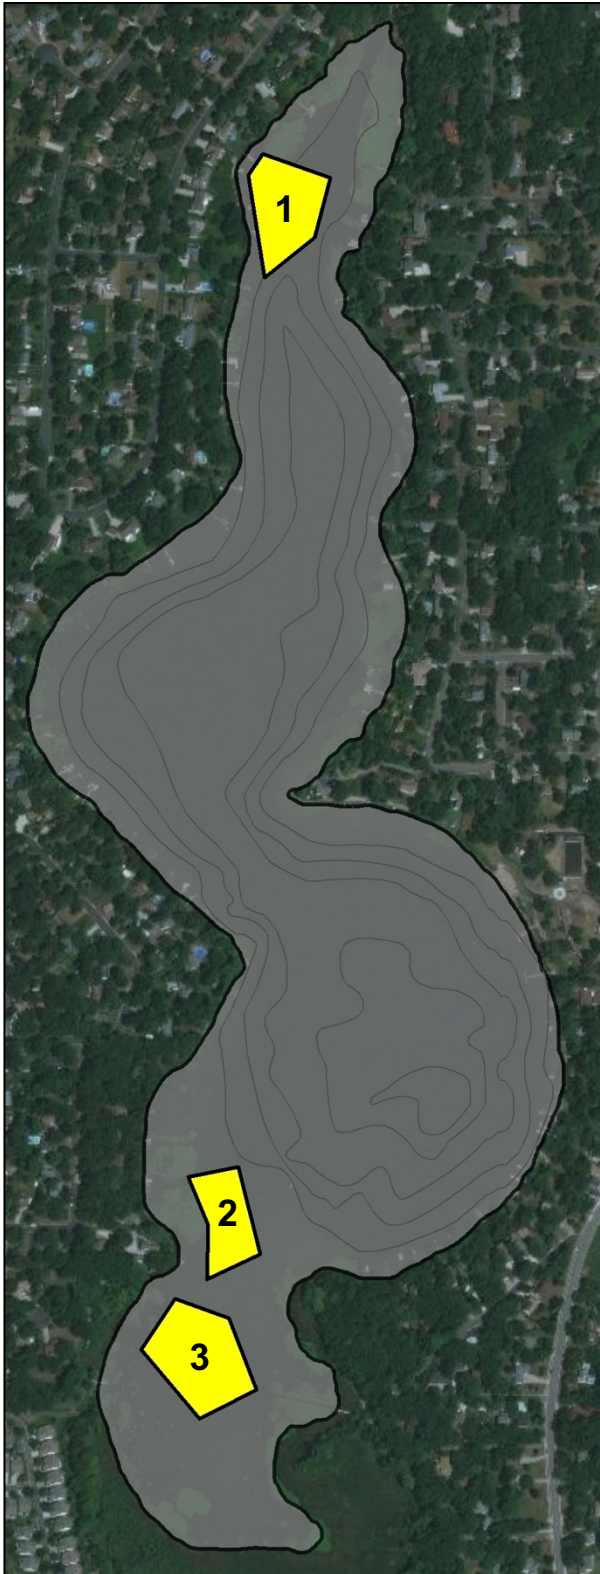
2020 Early-Spring Delineation of Curlyleaf Pondweed Crooked Lake (# 02-0084)

**Management Plots**

Plot	Area (acres)	Mean Depth (ft)	Mean EWM Density (1-3)
1	1.9	4.3	1.3
2	1.5	3.0	2.0
3	2.5	3.1	1.5

Total 5.9

Surveyed: April 6, 2020
Methods: Visual, Sonar, Rake
Surveyor: JA Johnson
